Manhole Inspection Summary

Manhole # S33II1021MH

Insp Date: **8/21/08 11:49 AM**

Location Address: **6 HIGHFIELD RD**

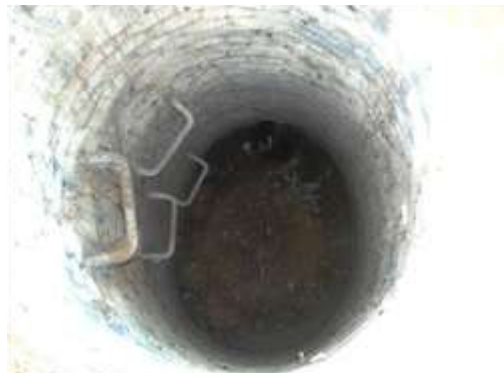
Top View

Channel debris.

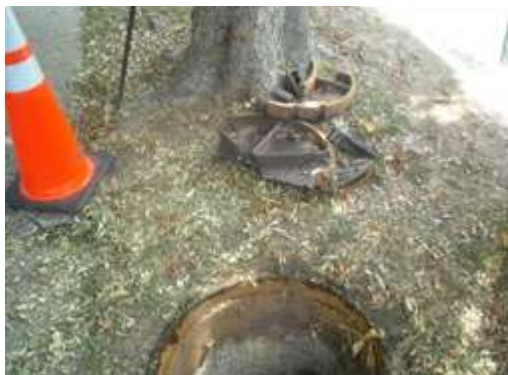
Broken lid

Comments **BROKE AND REPLACED LID TO COMPLETE INSPECTION**

Broke the lid to gain access.

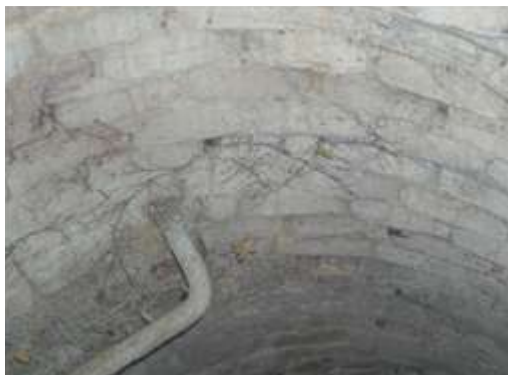
Defect

Condition: ☐ Sound ☐ Cracked ☒ **Root Intrusion** ☐ Loose Brick ☐ Deteriorated

Infiltration: ☐ None ☐ Joint ☐ Cracks ☒ **Mortar** ☒ **Roots** ☐ Wall

Corbel root intrusion and infiltration.

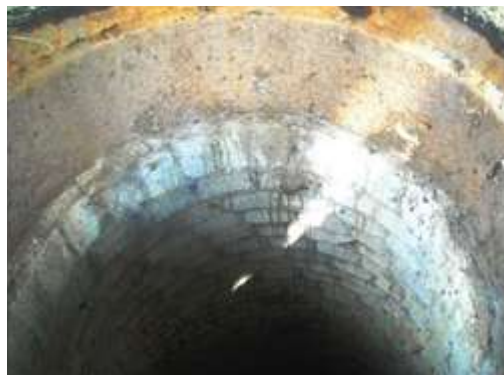
Defect

Frame Offset: **0** (in.) Condition: ☐ Sound ☐ Cracked ☒ **Leaks**

Infiltration: ☐ None ☒ **Joint** ☐ Cracks ☒ **Mortar** ☐ Roots ☐ Wall

Frame leaks. Adjustment, Corbel and Barrel infiltration.

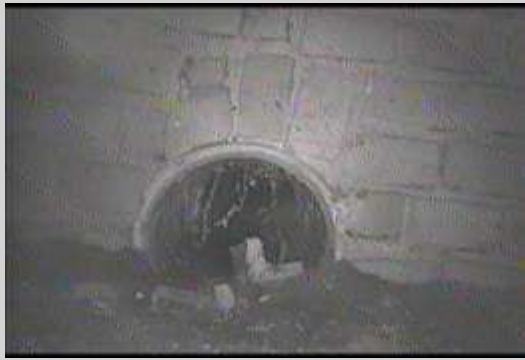
8 in. Circular Gravity Sewer
Pipe Out @ 12 O'Clock

Deposits: ☐ None ☒ **Mud** ☐ Sludge ☒ **Debris** ☐ Grease

Silt Depth: **2** (in.) Deposits Extent: **Light**
